approach

SEPTEMBER 1970 THE NAVAL AVIATION SAFETY REVIEW

MIDAIRS

A Continuing Threat

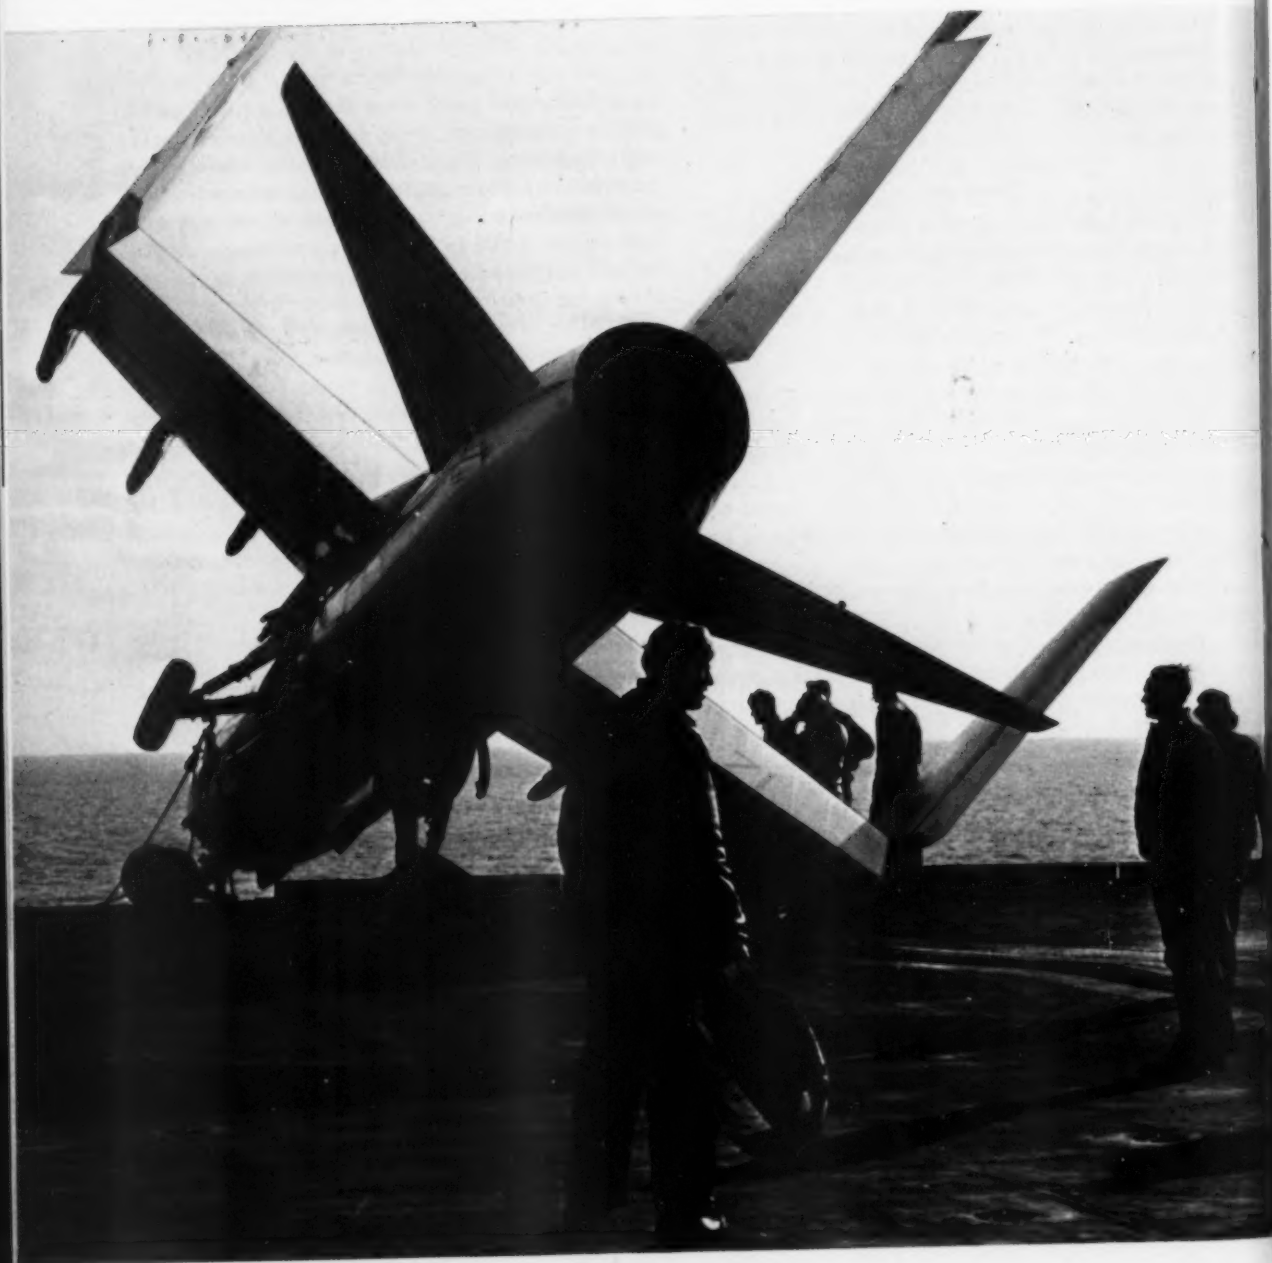
E Jet/Prop Blasts!

AN A-7 aircraft being taxied across the flight deck had to pass behind another A-7. At this time the axes of the two aircraft were nearly perpendicular. Before the moving aircraft could clear the area behind the other A-7, the pilot of the parked A-7 in front added power (about 80 percent). The resulting jet blast caused the taxiing A-7 to tip over on its wing (wings were folded at the time). The aircraft then began to skid toward the edge of the flight deck and the pilot, believing the aircraft was going over the side, ejected. After the pilot's ejection, the aircraft came to rest at the edge of the flight deck (see photo). The pilot survived the ejection but suffered major injuries.

All of these mishaps were avoidable. They could have been prevented if all the personnel concerned had obtained a better appreciation for the tremendous force of the jet/prop blast which exists behind aircraft which are operating at relatively high power settings. Pilots, plane directors and all other personnel who must work around aircraft when engines are operating must strive continuously to keep this hazard in mind.

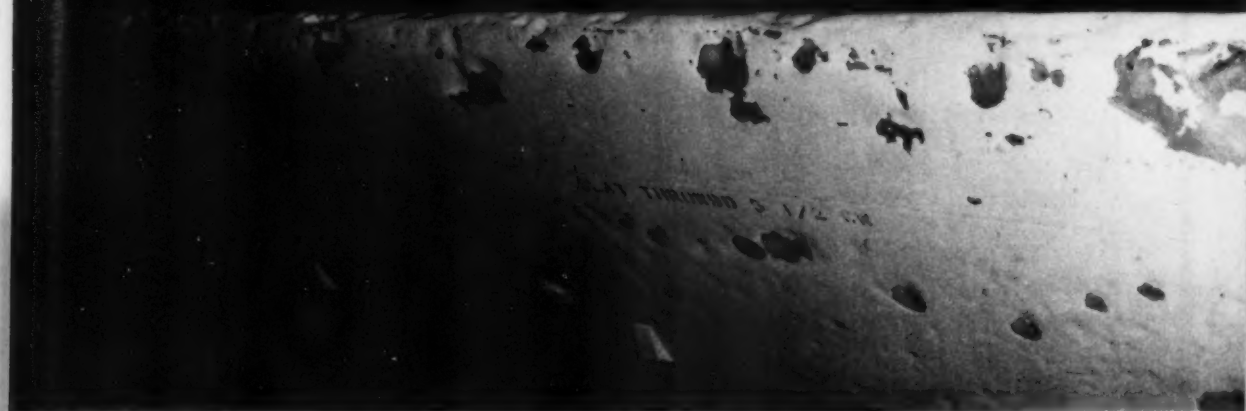
**HAIL
YES!**

AN *INTRUDER* was at flight level 280 enroute to a preplanned refueling stop in New Mexico. Enroute weather was generally IFR with stratus clouds but the aircraft was under control of an Air Route Traffic Control Center. About 44 minutes after takeoff a Severe Weather Warning area developed across their flight-planned route. Although the crew had been in radio contact with two Air Route Traffic Control Centers and several enroute METRO stations since becoming airborne, *no one had passed along the new WW information.*

When hailstones, some the size of baseballs, began to beat on the aircraft, speed was reduced from 300 to 250 kias. Suddenly there was a loud pop and a visible crack appeared in the BN's windscreen! The pilot and BN watched the crack spread as they lowered their seats and pulled their green visors down over their clear ones. The

pilot's windscreen began to crack, followed by a loud explosion and decompression as the left side windscreen blew out. Immediately there was a rush of air into the cockpit, accompanied by a near-deafening roar. Hailstones and ice chips smashed against the back of the cockpit and part of the instrument panel glare shield shattered.

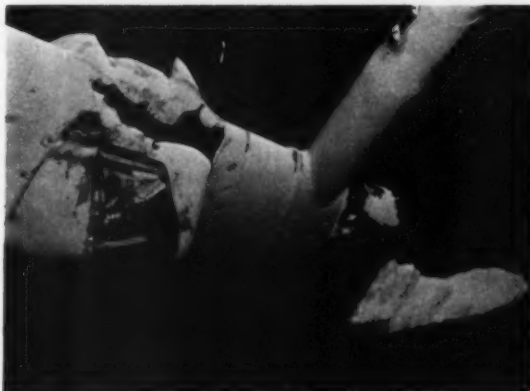
The damage sustained by this A-6 could easily have been caused by enemy ground fire or errant golf balls! Few aviators realize the destructive potential of hail found in thunderstorms until some event like this occurs. A little hail can go a long way towards spoiling your afternoon!

The aircraft was met by the base crash crew and flight surgeon. The BN was uninjured and the pilot had received minor injury to his left arm. Both men were visibly shaken by their encounter with Mother Nature. The aircraft, also visibly shaken, did not fare as well. Damage to exposed surfaces ranged from minor to severe, generally depending on how perpendicular the surfaces were to the free airstream. Neither of the J52 engines was damaged.

Don't wait until face to face with a thunderstorm to learn what actions to take. Prepare yourself now for what may happen when Mother Nature decides to do her worst. — Ed.

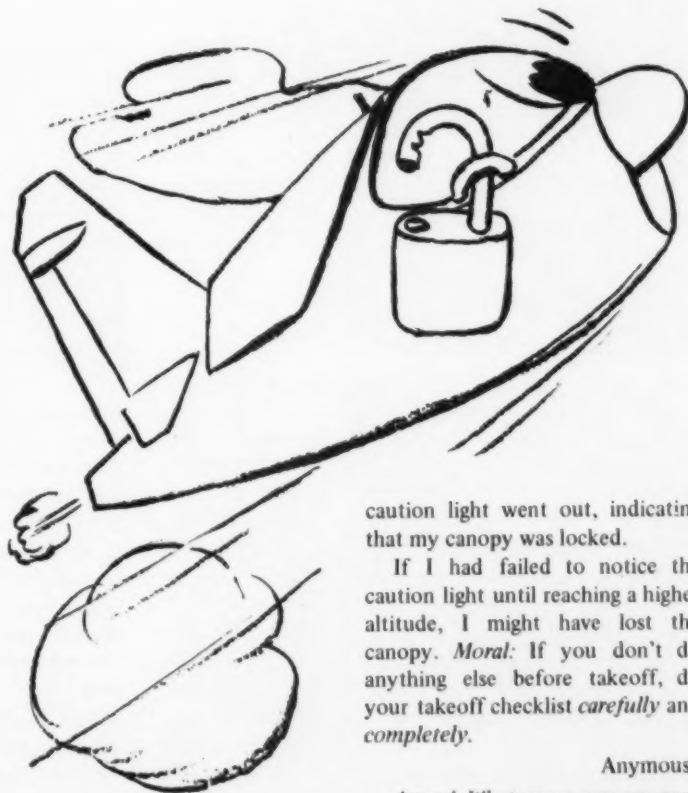
Passing through 10,000 feet (and when it was considerably darker) I noticed the caution light. The fact that I was No. 2 man and had to keep my leader in sight under difficult lighting conditions may have contributed to my failure to notice the caution light earlier.

I gingerly pushed the handle forward another inch or so and the

caution light went out, indicating that my canopy was locked.

If I had failed to notice the caution light until reaching a higher altitude, I might have lost the canopy. *Moral:* If you don't do anything else before takeoff, do your takeoff checklist *carefully* and *completely*.
